## Test Intention:

In test 4904 we want to investigate the lifespan of a CF38.250.04 in an e-chain with a 175mm radius.

Series / No: CF38      Installation type: horizontal, short way

e-chain® type: E4.42.07.175.0

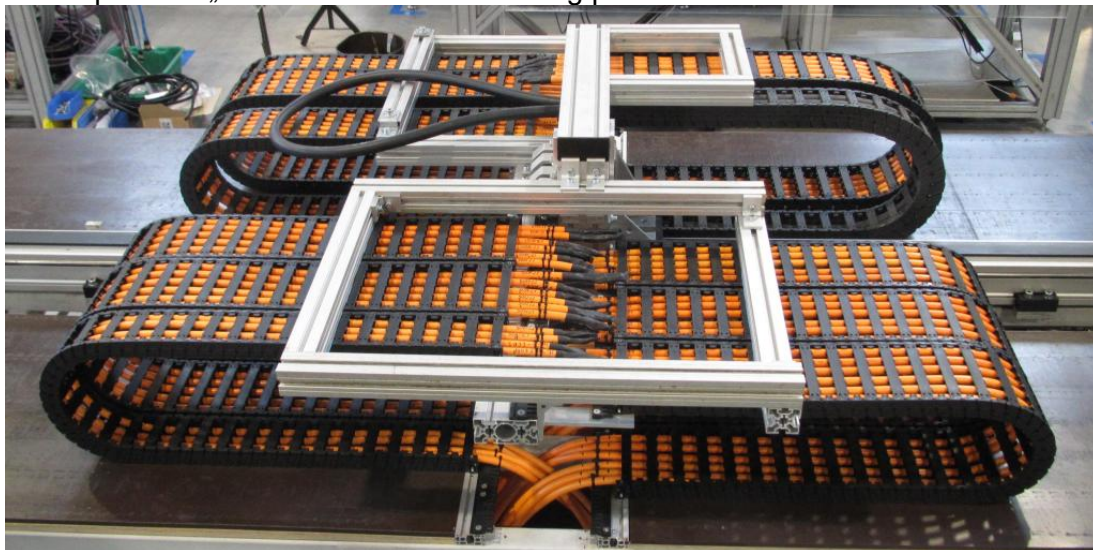
## 1. Construction:

This test is built up on the „Maschine 56“. The following picture shows the test structure:

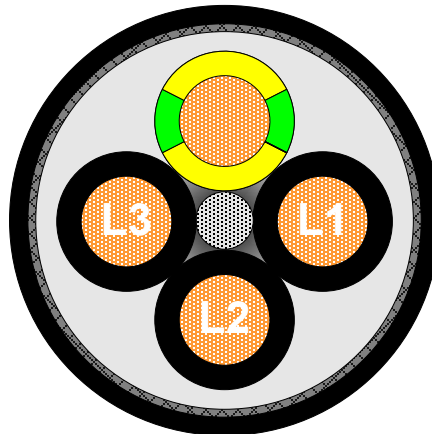
## 3. Description of the cable construction:

No. 1: **2x CF38.250.04** with the cable marking  
03262m igus chainflex CF38.250.04 (4G25)C 600/1000V CE N P/AE RoHS-II conform  
www.igus.de

Standard igus chainflex® catalogue cable

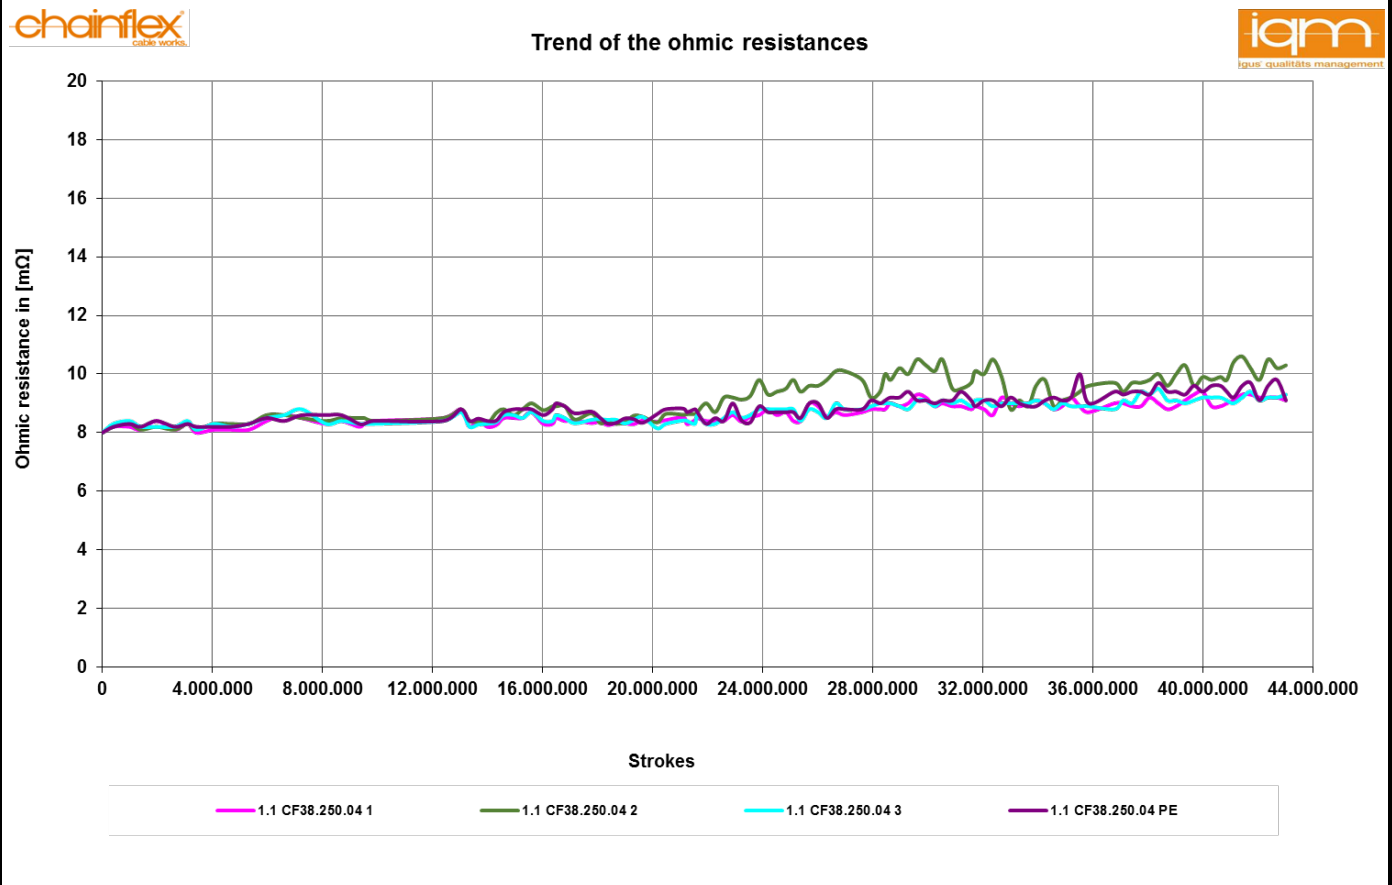
At the 09.02.2017 we demounted the cables after 43.000.126 strokes because we want to finalize the test.

The following chart shows the trend of the ohmic resistance after 43.000.126 strokes:

To detect broken conductor or shielding wires we will measure the ohmic resistance of these cable elements.

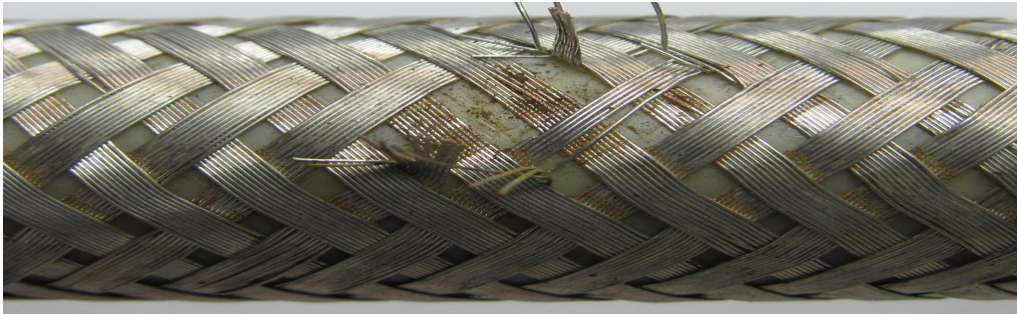
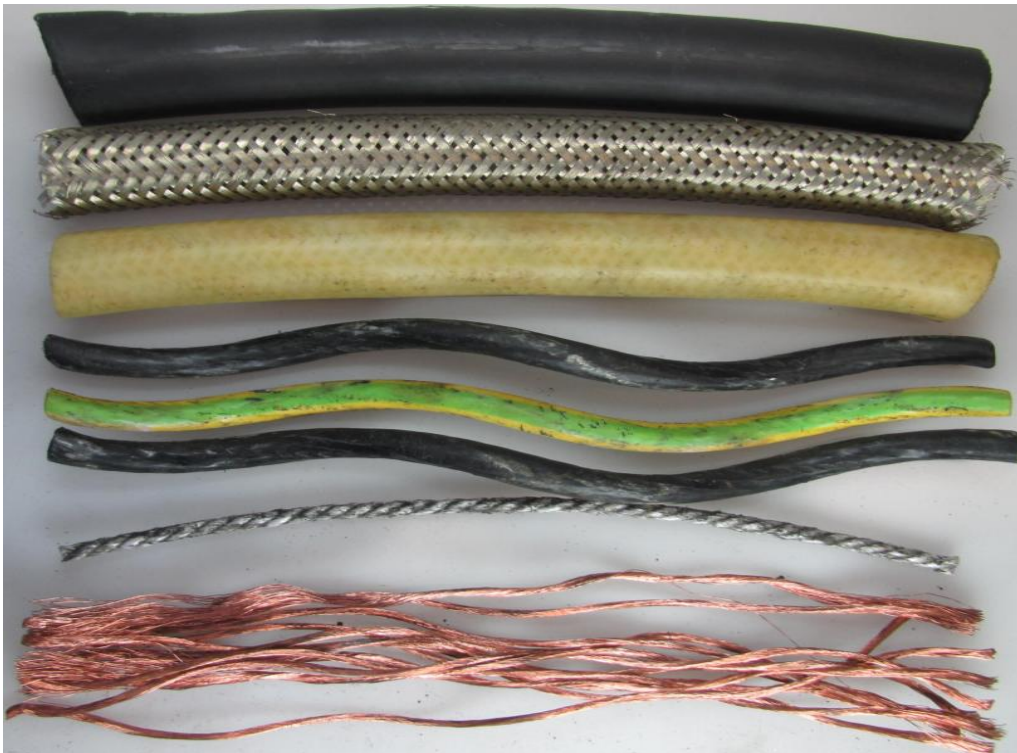
#### The condition of the cable no.1.1 (CF38.250.04) after 43.000.126 strokes

Strokes	43.000.126
Condition outer jacket	O.K.
Condition overall shielding	Broken wires
Condition inner jacket	O.K.
Condition centre element	O.K.
Condition core insulation	O.K.
Condition conductor	O.K.

The following pictures show the dissected elements of the cables

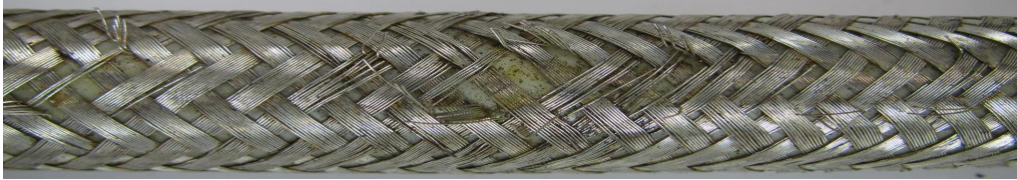
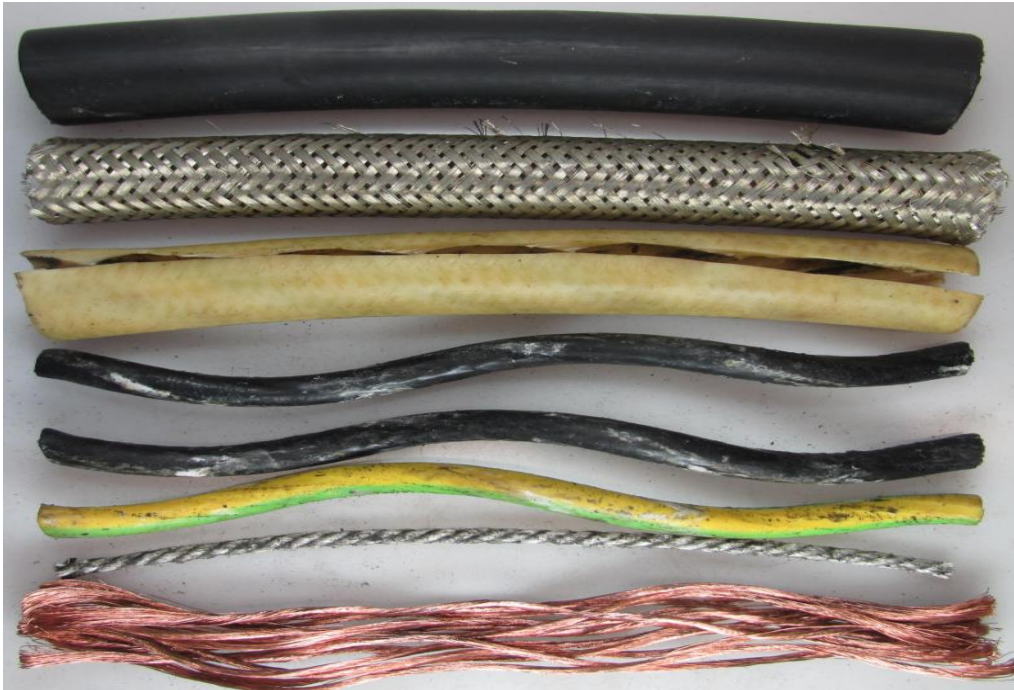
## The condition of the cable no.1.2 (CF38.250.04) after 43.000.126 strokes

Strokes	43.000.126
Condition outer jacket	O.K.
Condition overall shielding	Broken wires
Condition inner jacket	O.K.
Condition centre element	O.K.
Condition core insulation	O.K.
Condition conductor	Single wires broken
